SPE-207840-MS

Lead Application to Cure Sap Wells by Deploying Straddle Packer, Success Story

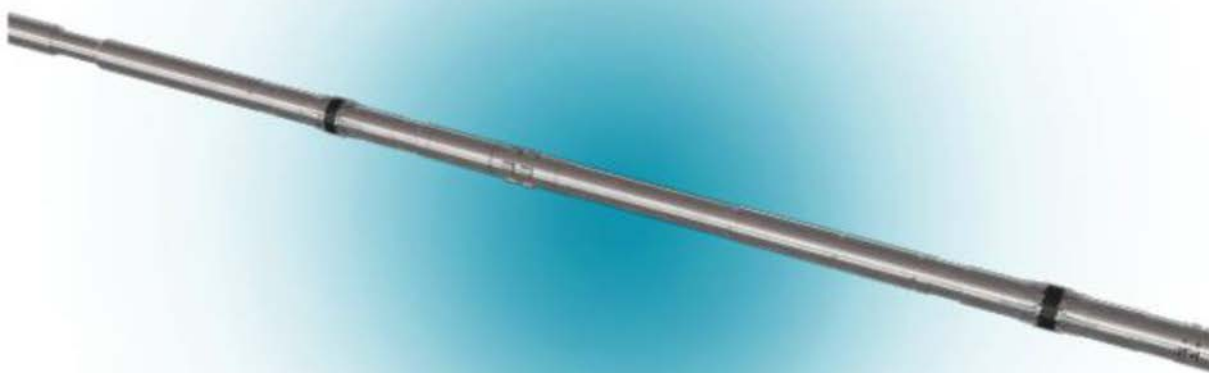
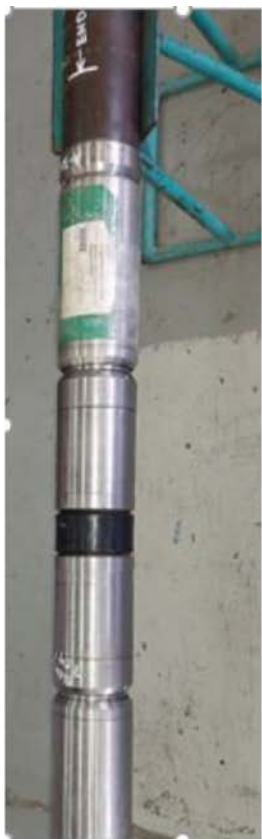
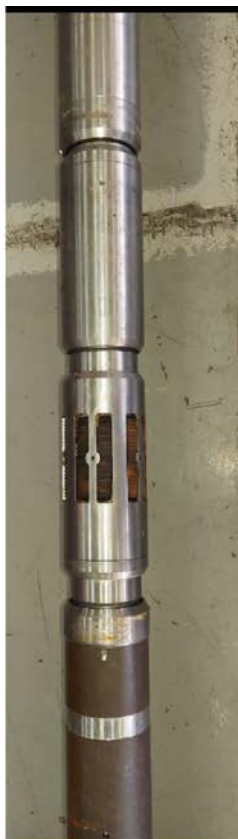
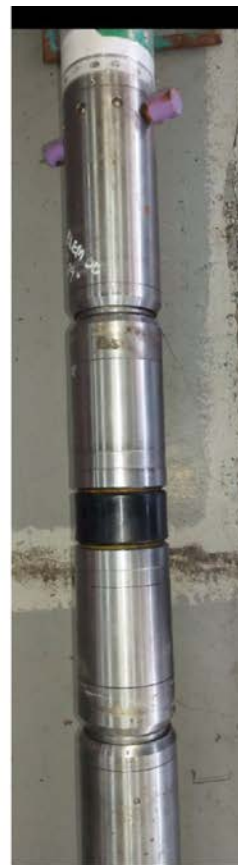
Simply it is two tandem packer elements with spacer pipe in between in addition to anchoring system to be set across the point of communication to isolate the interval of concern whether it is a communication point between tubing and annulus or it is a corroded interval or it is a malfunctioning completion accessory, allowing the fluid to pass through bypassing the point of interest. Each Packer Module consists of a one-piece solid elastomer element supported by a tight mechanical barrier on each side. When expanded, a radial wall prevents extrusion of the packer element under strain or pressure.

Figure 2—Straddle packer assembly

Bottom packer

Anchoring Slips

Top packer

Straddle packer application is consists of two tandom packers with spacer pipe in between with anchoring system deployed riglessly in the well to isolate the communication point between Ann A and Tubing. Fig-2,

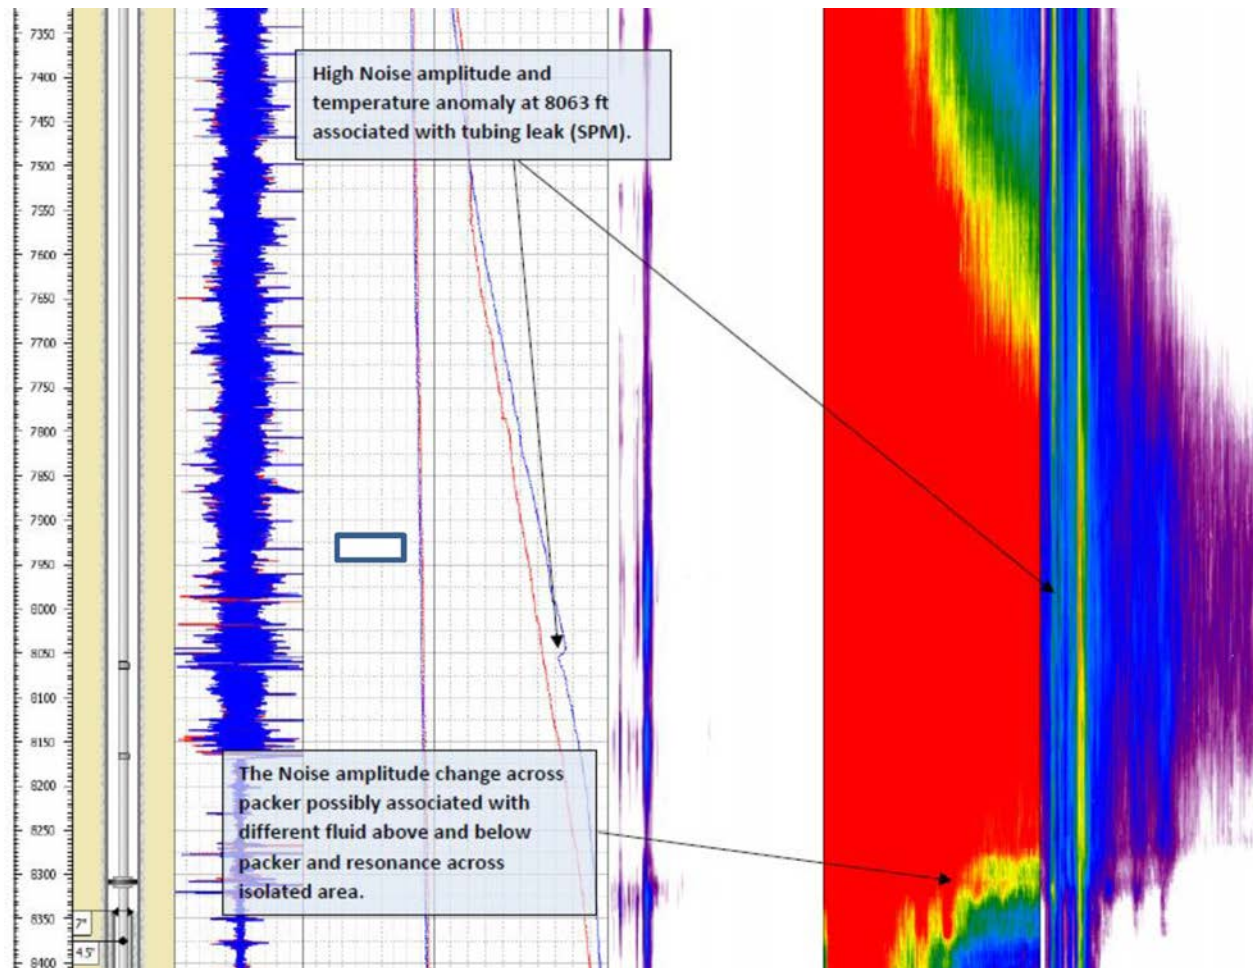
- Finally identified clearly the main communication point is at top SPM at depth 8067 ft RTKB
Fig-3

Figure 3—Noise/TEMP log graph as SPM depth

As shown below the high intensive noise was observed at SPM depth in which is supported by temperature anomaly at the same depth which is supporting the conclusion of having gas flow at this point

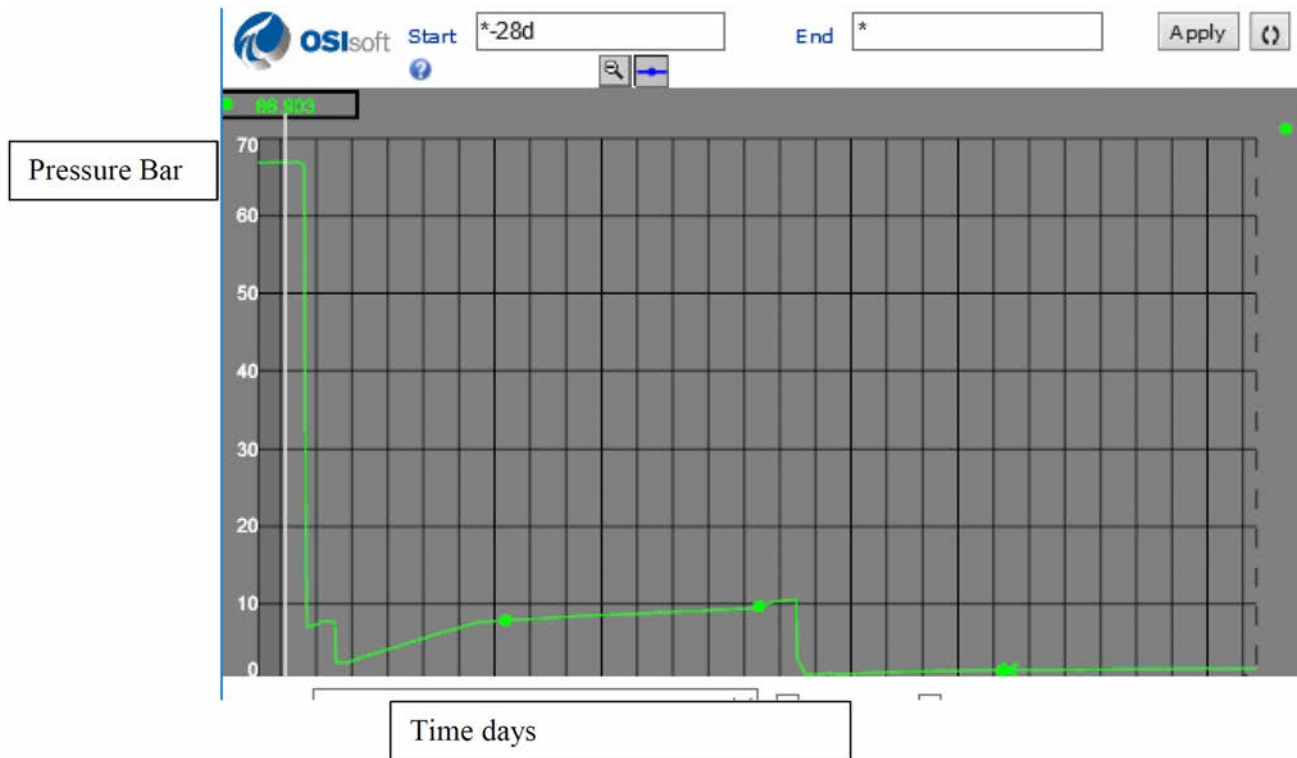
Below is the annulus pressure graph showing WHP is 66 bar and annulus pressure is 5 bars then zero bar with no pressure build up in annulus side, Which is a clear confirmation the leaking completion accessory was isolated with [Fig-5](#)

Figure 5—Annulus A pressure graph post setting straddle packer assembly
