Case Study: First run IVC in Middle East

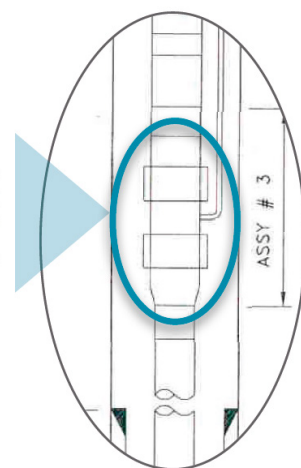
Failed DHSV,
Interwell IVC
set in 3.81”
Nipple profile

Interwell ran and set a tailor-made Insert Valve Carrier (IVC) to retrofit the third party replacement valve inside the existing safety valve profile. Interwell custom designed the 369-450 ISO14310 Vo tool for this well, and was developed to capitalize on the existing equipment in the hole. This was the first installation of an IVC in the Middle East region.

Interwell successfully installed an IVC assembly inside the existing safety valve profile. The client managed to re-start production immediately and saved a costly workover of approx. \$5 million. The well is back to producing 3000 BPD.
