# Case Study: Re-establish Gas Lift using APS to recover stuck valve

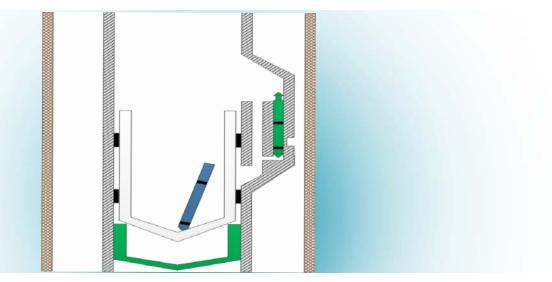
Interwell came up with a specially designed single run Anchored Production Straddle (APS). The elements on this straddle were both located near the top of the device, perfectly spaced out to straddle the bottom communication port and seal again at the midpoint of the pocket leaving the upper part of the pocket free of any obstruction. The straddle also had a perforated catcher sub fitted to the bottom of the system. The straddle was correlated to depth by the client firstly setting a Medium Expansion (ME) retrievable bridge plug below the side pocket mandrel using the Kick Over Tool to place the plug on depth.
